# Manhole Inspection Summary

## Manhole # S21CC1060MH

**Location** Address: **CLIPPER PARK RD**

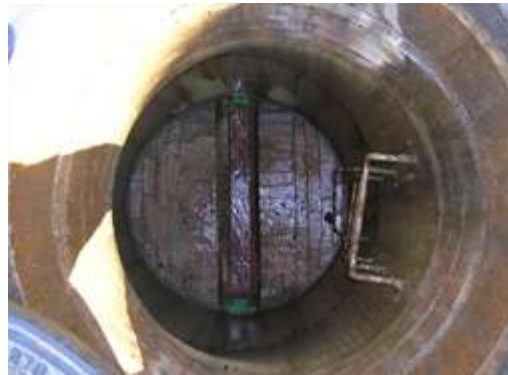
Top View

Bench debris.

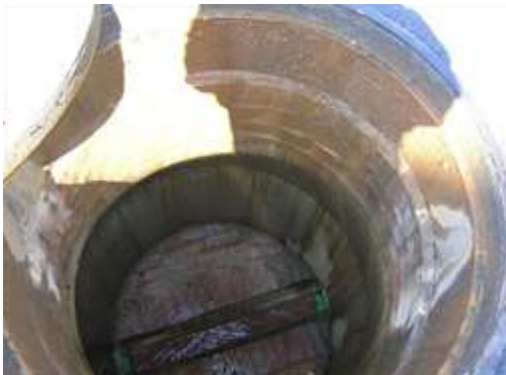
Defect

Frame leaks. Frame leaks. Adjustment, Corbel and Barrel infiltration.

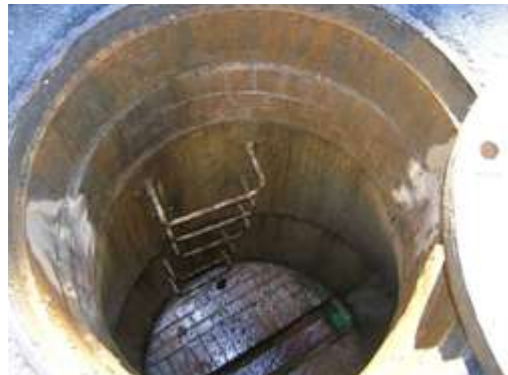
Defect

Frame leaks. Adjustment, Corbel and Barrel infiltration - other side.

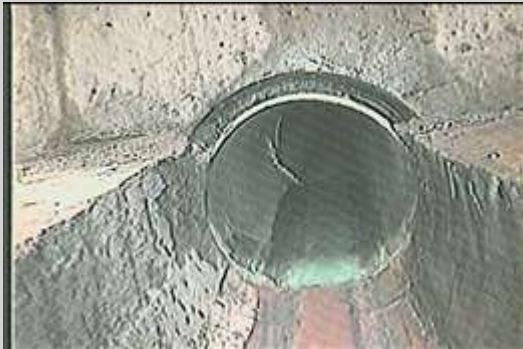
### 10 in. Circular Gravity Sewer Pipe Out @ 12 O'Clock

Comments **Both pipe seals are not flush to the pipe.**

Infiltration: **Evidence** Pipe Seal Cond: **Unknown**

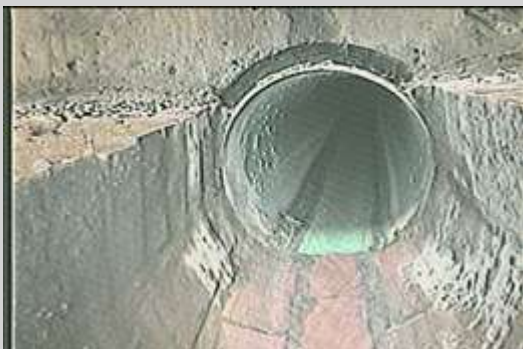
### 10 in. Circular Gravity Sewer Pipe In @ 6 O'Clock

Infiltration: **Evidence** Pipe Seal Cond: **Unknown**
